# MESOGGEION AEROCLUB

## 1<sup>ST</sup> Safety Awareness Bulletin

December 2016

ATO-SAB-01

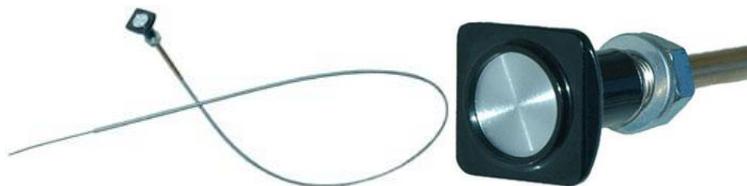
In terms of engineering factors the situation is much more specific. The most popular failure is that of the carb heat lever. This mechanical failure occurs when the carb heat lever is operated violently especially when set from the carb heat on to the carb heat off position (lever pushed towards the panel).

Figure 11 The carb heat control with its cabling is one of the most often replaced parts in C172s globally

In the long run, fatigue caused by abrupt operation of the lever causes the carb heat cabling to fail. If the carb heat is stuck in the hot position, it will prevent icing build up but it will incur a performance penalty due to lower RPM and additional engine wear due to a very rich mixture. On the other hand, when stuck in the cold position there is a possibility for carburetor icing. As both situations are problematic **it is important to operate smoothly and gently all controls and levers**. With the exception of the primer lever (which is harder to operate), no control or lever requires excessive strength.

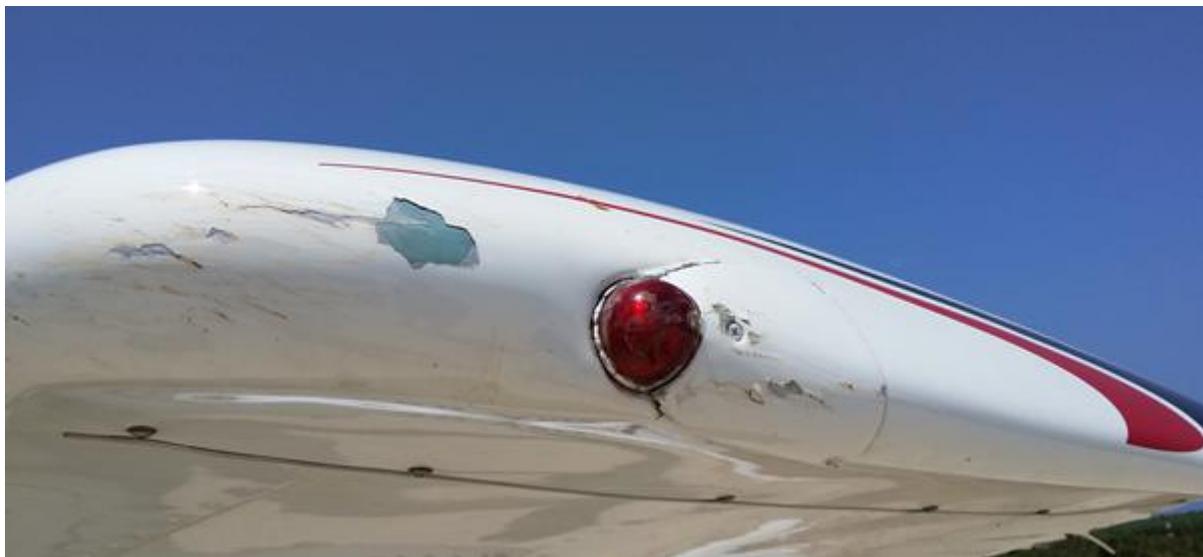
The last two sentences summarise the PIC's experience of the occurrence and point in the right direction. What would have normally been a routine taxiing manoeuvre led to a situation involving a number of people, increased workload, and minor damage to the aircraft. The PIC did not manage to control the situation. Although taxiing is thought to be a routine and easy part of our flight, it is one which requires that we are in control of the aircraft at all times. When the aircraft is moving we should not allow ourselves to be distracted by issues inside or outside the aircraft itself.

Figure 14 The left wing hit the fence and obtained minor damage
