# MESOGGEION AEROCLUB

## 1<sup>ST</sup> Safety Awareness Bulletin

December 2016

ATO-SAB-01

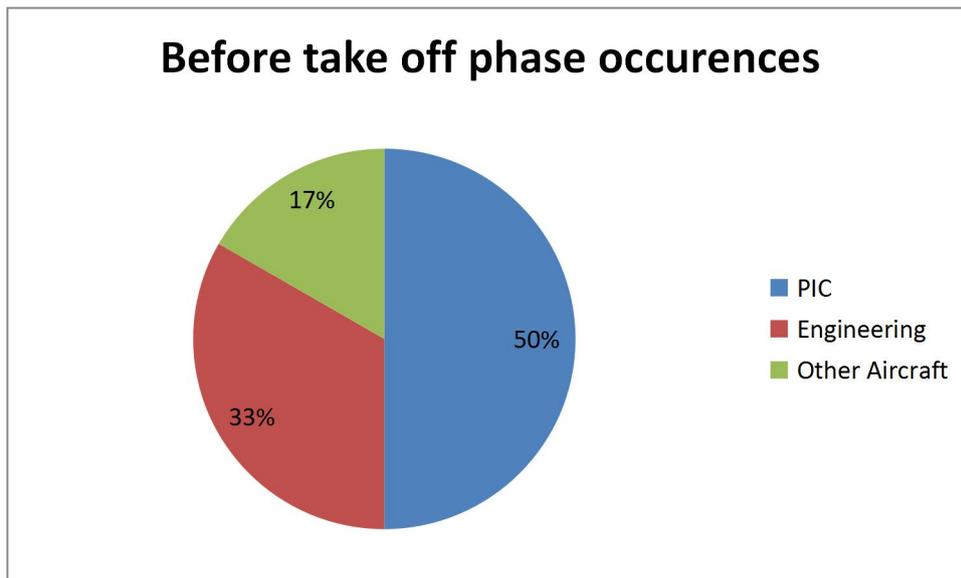
Figure 10 PIC and Engineering are the main causal factors

In terms of engineering factors the situation is much more specific. The most popular failure is that of the carb heat lever. This mechanical failure occurs when the carb heat lever is operated violently especially when set from the carb heat on to the carb heat off position (lever pushed towards the panel).

In the long run, fatigue caused by abrupt operation of the lever causes the carb heat cabling to fail. If the carb heat is stuck in the hot position, it will prevent icing build up but it will incur a performance penalty due to lower RPM and additional engine wear due to a very rich mixture. On the other hand, when stuck in the cold position there is a possibility for carburetor icing. As both situations are problematic **it is important to operate smoothly and gently all controls and levers**. With the exception of the primer lever (which is harder to operate), no control or lever requires excessive strength.
